June 8, 2017

**Re: Structural Conditions Inspection
Old Grace Church & Servants Cottage
4755 Merrick Road Massapequa, N.Y.
H2M Project No.: MAHS 1701**

Structural Conditions Inspection
Massapequa Historical Society

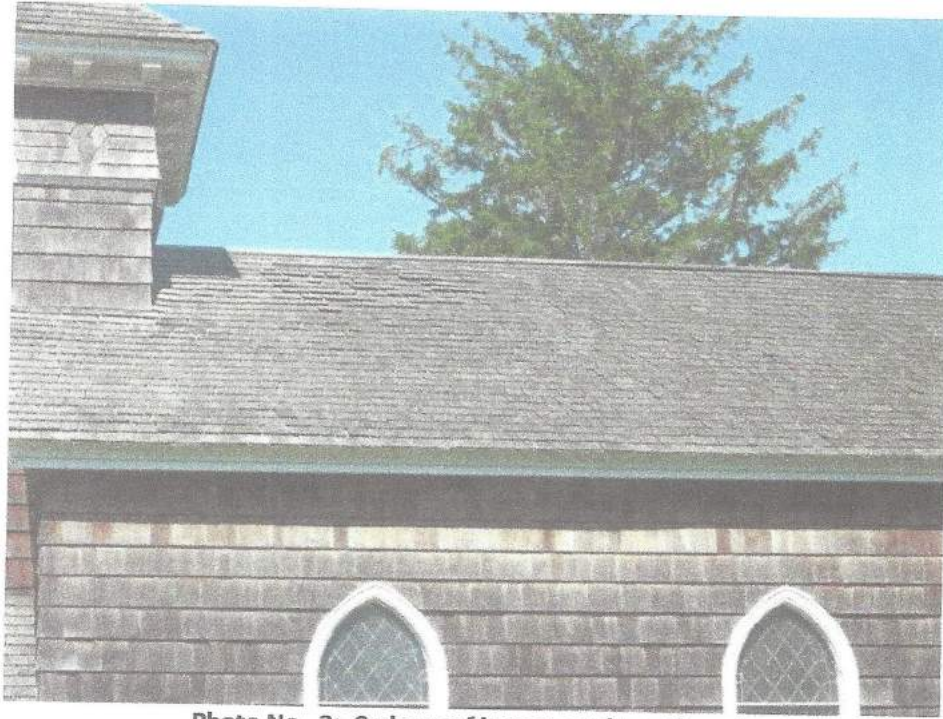
- The main gable roof shingles and two rear (north) gable roof shingles are in poor condition.
- Most surface areas are severely worn and weathered. (Refer to Photo No. 3.)
- Deterioration is evident along the exposed edges.
- Material shrinkage has occurred over time.
- Most shingle pieces have cupping and lifting. (Refer to Photo No. 4.)
- Moss and Lichens have developed across the surface of each surface of each side of these gable roofs.
- The ridge boards are not tight to each other and the roof surface. This will allow for water infiltration.

Photo No. 3: Cedar roof is worn and weathered.

The cedar roof needs to be replaced. The existing roof may last 1-2 years further if leaking has not begun to occur.

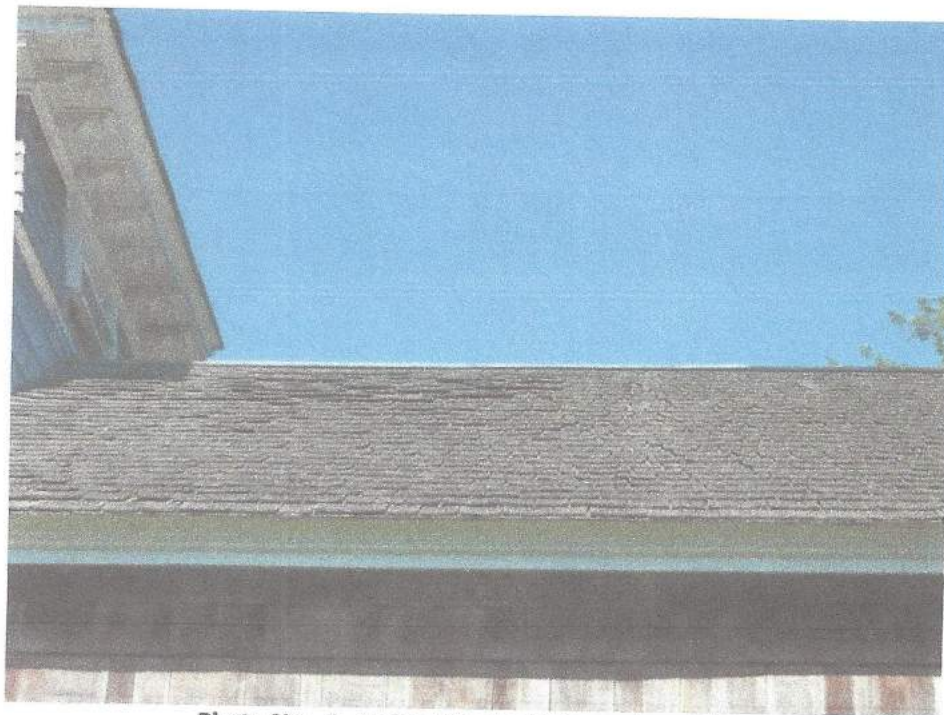
Photo No. 4: Cedar shingles lifting and cupping.

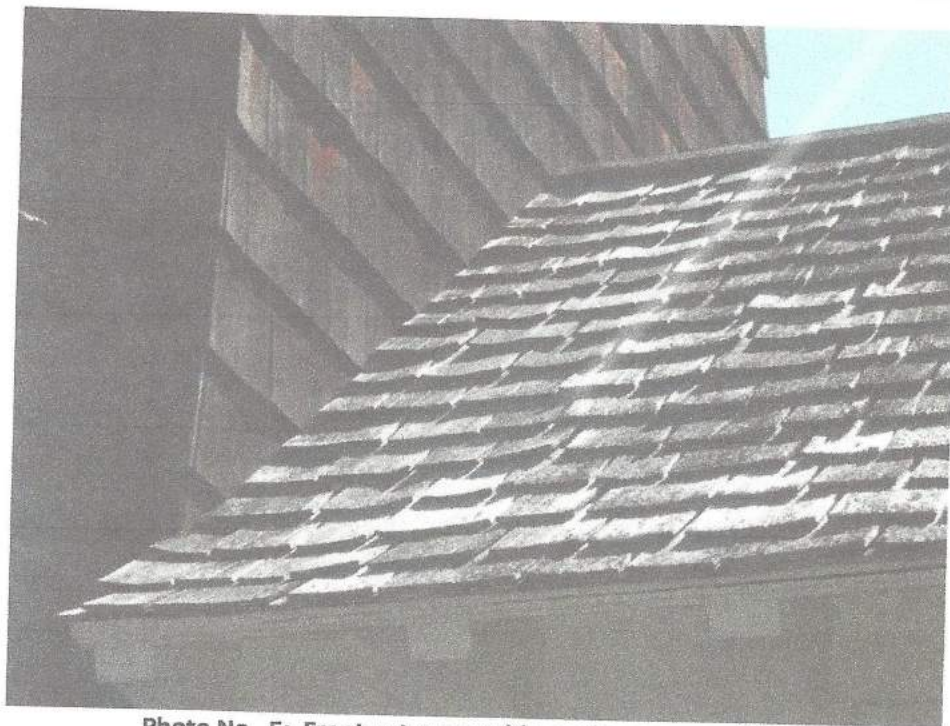
- The front entrance gable roof and two side shed roofs are in poor condition. (Refer to Photo No. 5.)
- Most surface areas are severely worn and weathered.
- Deterioration is evident along the exposed edges.
- Material shrinkage has occurred over time.
- Most shingle pieces have cupping and lifting.
- Moss and Lichens have developed across the surface of each surface of each side of these gable roofs.
- The ridge boards are not tight to each other and the roof surface. This will allow for water infiltration. (Refer to Photo No. 6.)
- There are a few missing cedar shingles pieces.
- There is a separation that has developed between the cedar roof shingles and the cedar siding shingles. This may be an avenue for water infiltration and decay.

Photo No. 5: Front entrance gable roof in poor condition.

The cedar roof needs to be replaced. The existing roof is deteriorating. Leaking may be occurring already. Repair should be immediate to avoid damage to the structural members.

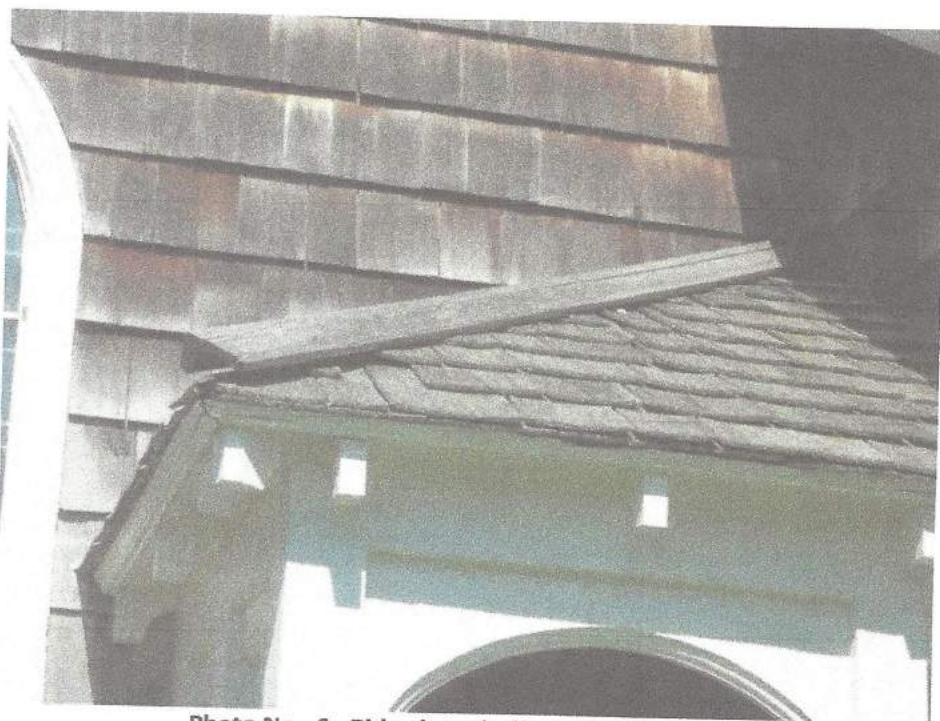
Photo No. 6: Ridge boards displaced from roof.

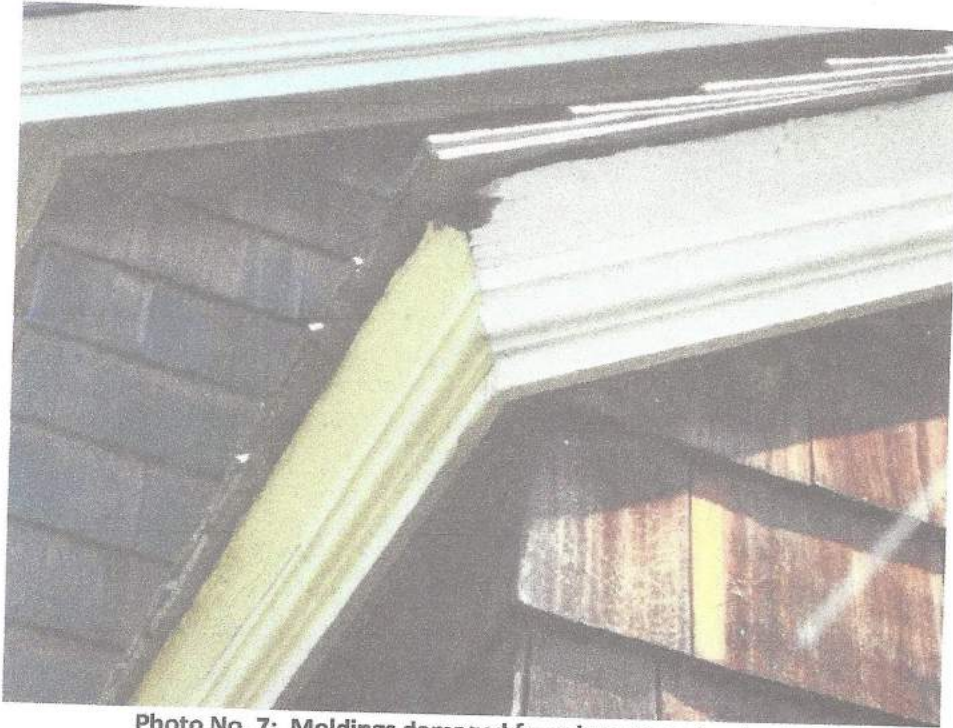
- The cedar shingle siding is in fair condition slightly weathered.
- Some shingles are lifting.
- The corner edges are separated. Some corners edges are missing.
- There is a slight material shrinkage causing joints to separate.
- The trim is in fair to good condition. the molding corners need repair from insects and rodents. (Refer to Photo No. 7.)

Photo No. 7: Moldings damaged from insects and rodents.

Immediate maintenance is recommended to avoid further damage or decay.

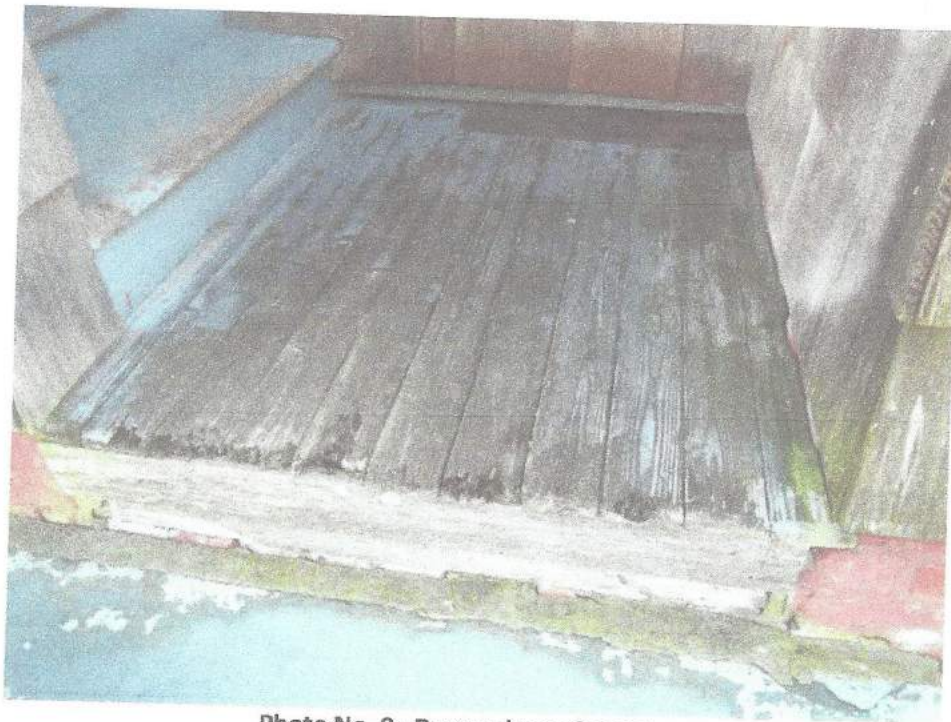
- The wood decking is in poor condition. The wood is decayed and is potentially dangerous due to its weakened condition. (Refer to Photo No. 8.)
- The stone steps have settlement. Repointing of the masonry joints is recommended. (Refer to Photo No. 9.)

Photo No. 8: Decayed wood decking.

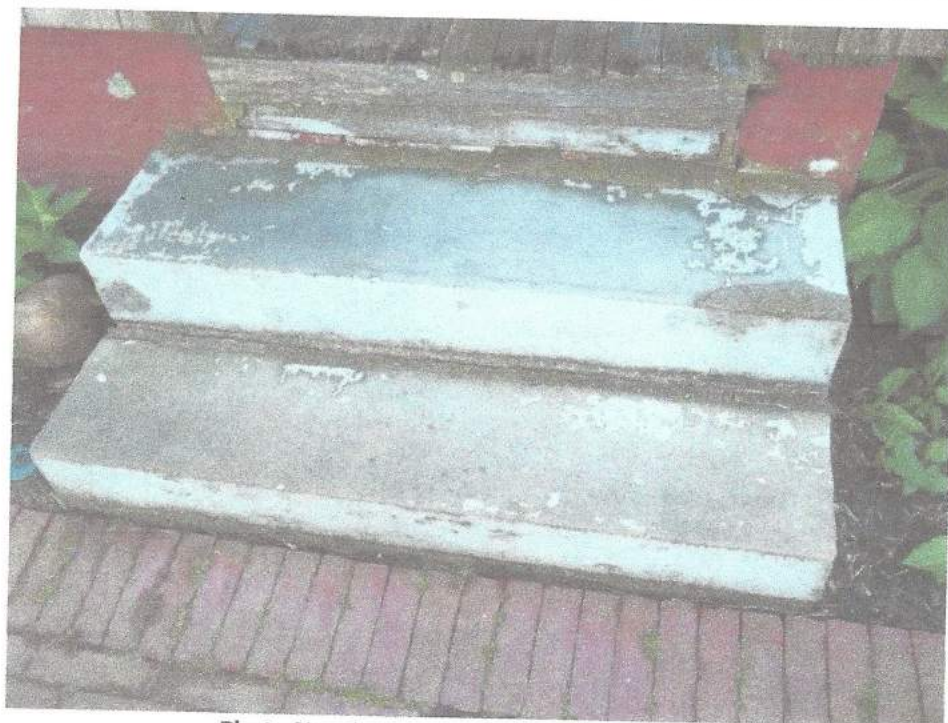
Photo No. 9: Stone steps for the side porch.

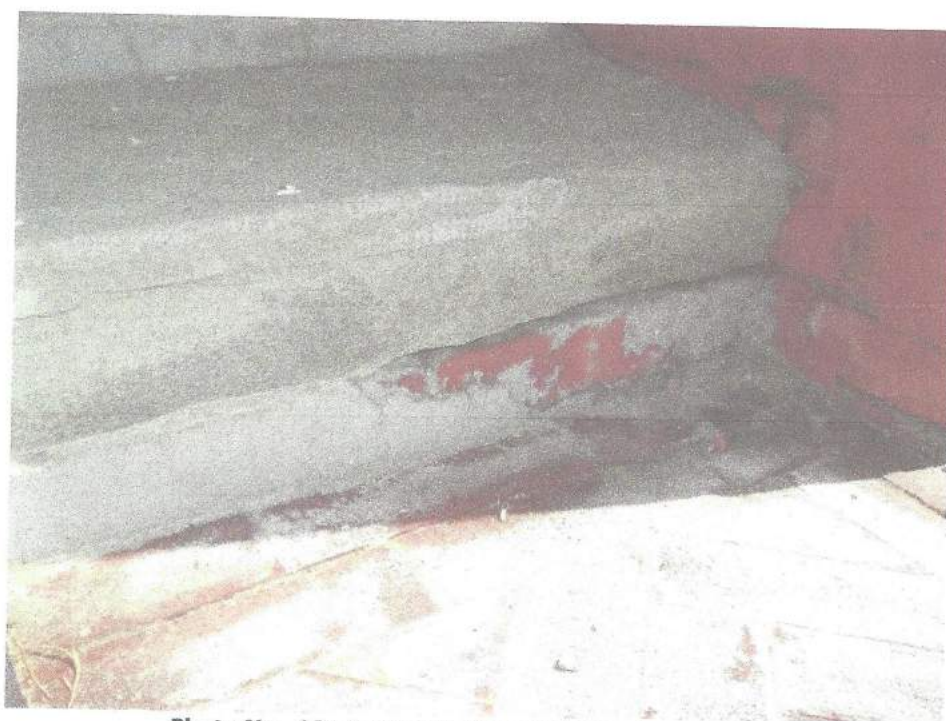
- The brick supporting the stone steps need repointing. (Refer to Photo No. 10.)
- Several walkway bricks are displaced downward causing a tripping hazard. Immediate repair is recommended. (Refer to Photo No. 11.)
- Brick surface repointing is recommended.
- The brick support walls for the roof over are deteriorated. Repair/replacement is recommended.
- The lower brick is severely decayed. Replacement is recommended. (Refer to Photo No. 12.)

Photo No. 10: Front entrance steps need repointing.

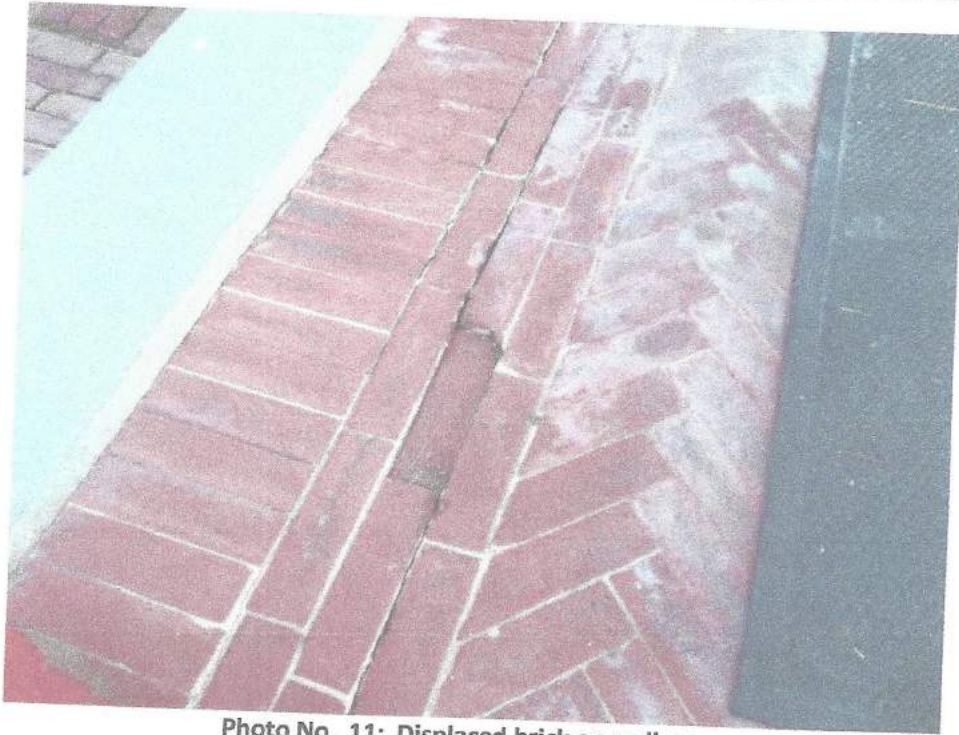
Photo No. 11: Displaced brick on walkway.

The brick masonry along the walkways should be reset/replaced immediately. The damaged brick along the lower walls should be repaired within the next 4-6 months.

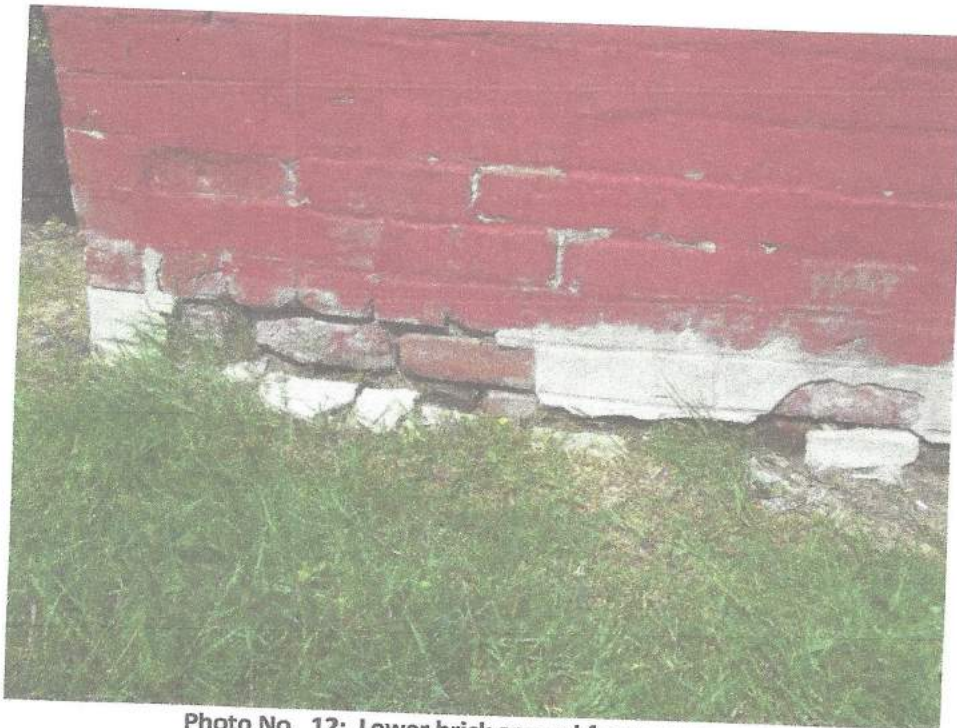
Photo No. 12: Lower brick around front entrance.

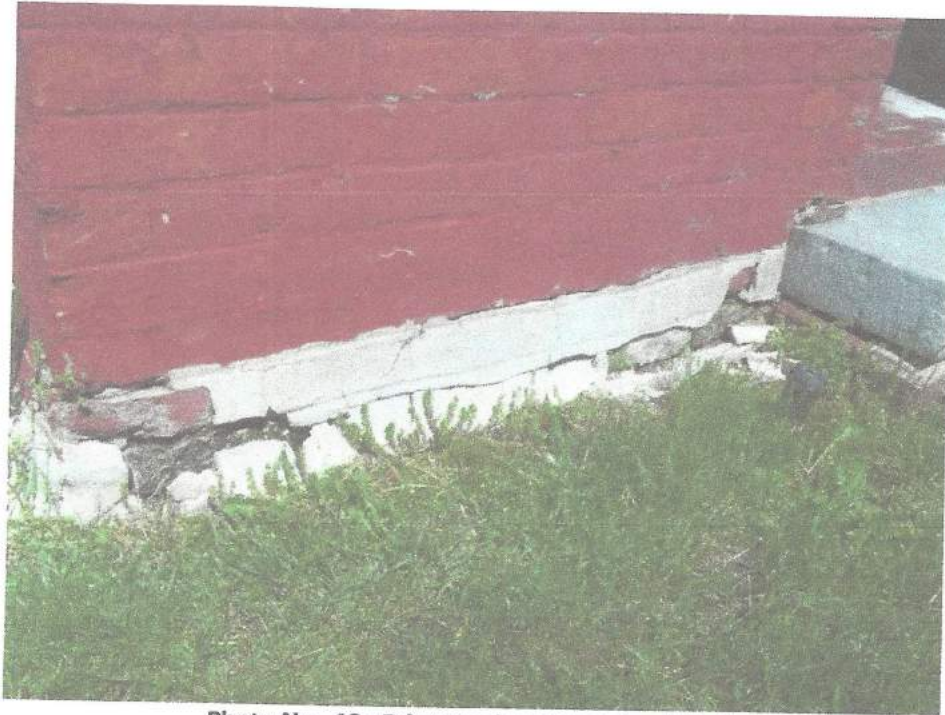
- The lower brick courses have severe deterioration. Repair/replacement is recommended.
- Prior repair is apparent and have failed. (Refer to Photo No. 13.)
- Repointing is needed in several areas. (Refer to Photo No. 14.)
- There is minor overall cracking.
- The foundation shows no signs of settlement or displacement.

Photo No. 13: Prior repair attempt has failed.

The damaged brick along the lower walls should be repaired within the next 4-6 months. Repointing of the foundation is recommended in the next 1-2 years.

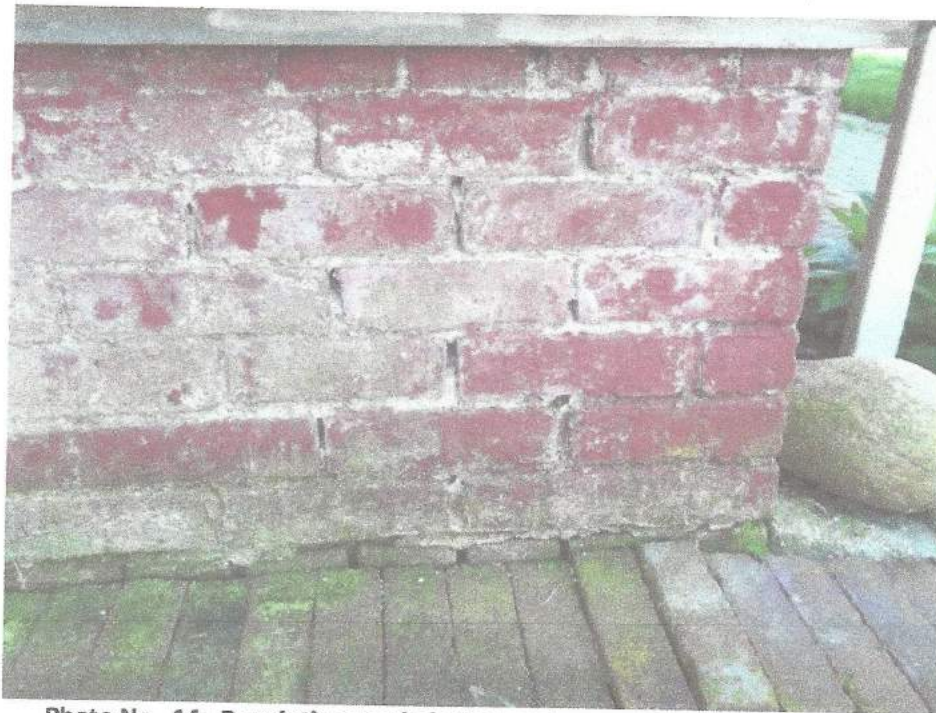
Photo No. 14: Repointing needed at several areas around the foundation.

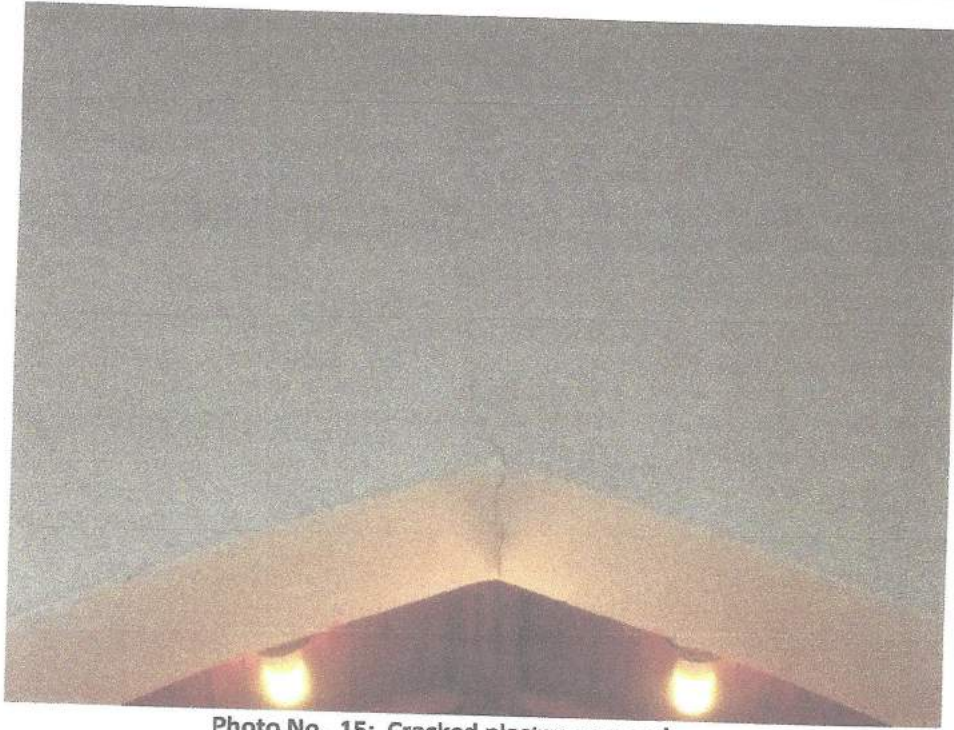
- Plaster walls and arch ways are in good condition.
- Minor surface cracking with prior repair apparent.
- Cosmetic repairs are needed.
- Wood lower wall panels and wood cathedral ceiling appear to be in good condition. No indication of movement or deflection.
- The wood floors appear to be mostly level.
- The main arch over the alter area has a crack at the peak that runs vertically upward toward the ridge. This should be patched and monitored overtime. (Refer to Photo No. 15.)
- Several plaster cracks and water staining are apparent at and around the alter area. Repair of the cracking and monitoring is recommended. (Refer to Photo No. 16.)

Photo No. 15: Cracked plaster over archway.

The existing cracks should be repaired and monitored to determine if there is any further movement.

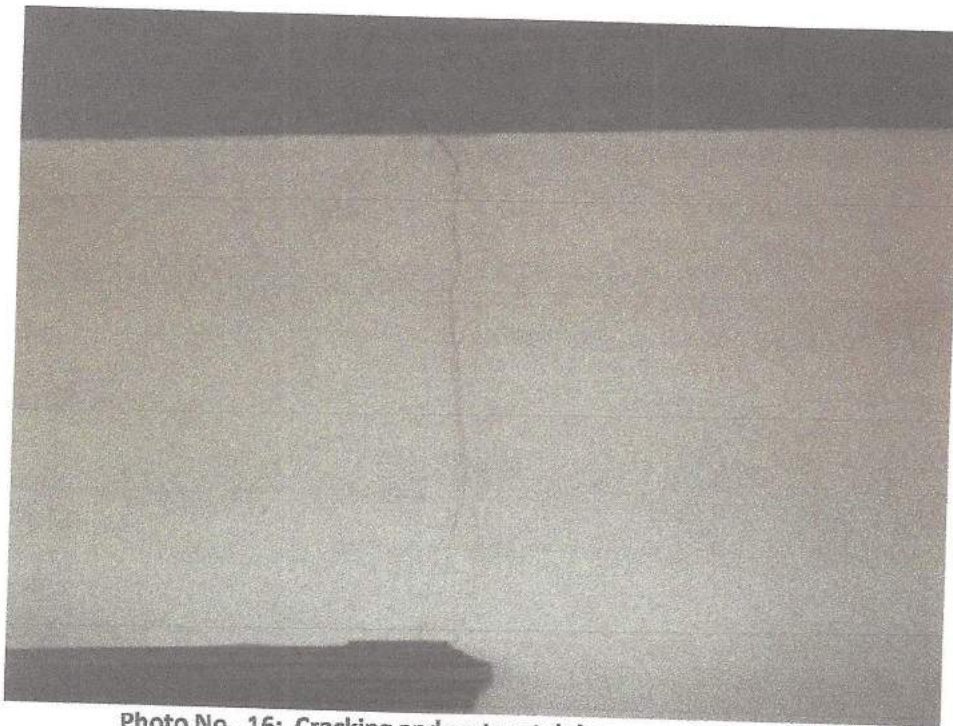
Photo No. 16: Cracking and water staining around alter area.

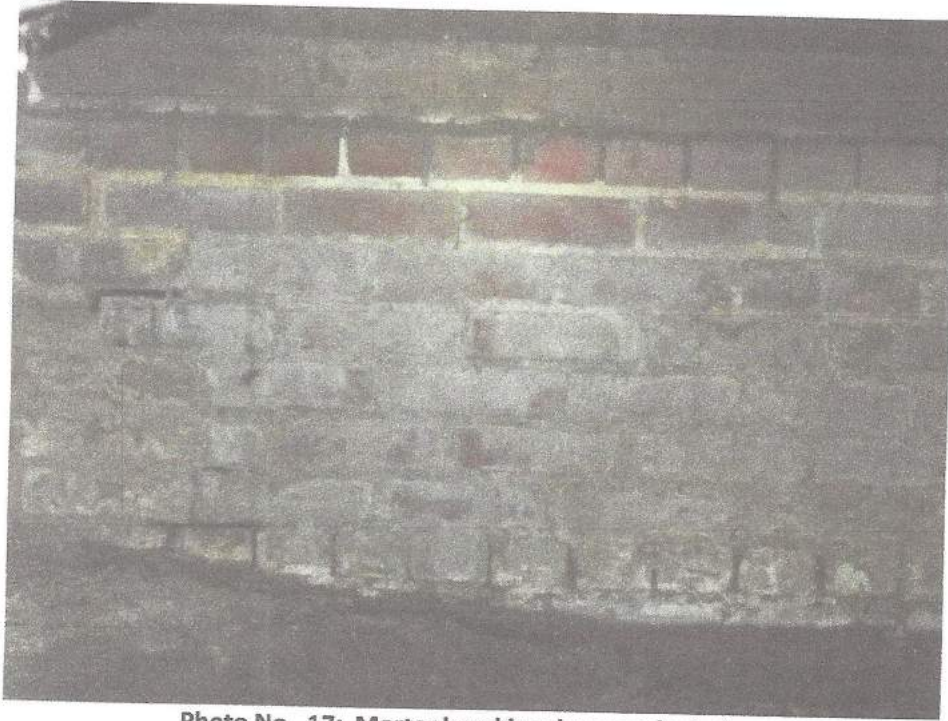
- A brick masonry foundation exists around the perimeter of the church structure.
- Brick patching and infill and prior repairs are apparent.
- Prior repointing is apparent in several locations along the perimeter.
- Older mortar is breaking down and missing in several surface areas of the perimeter foundation. (Refer to Photo No. 17.)
- The rear full depth brick masonry foundation area has some missing and loose brick. (Refer to Photo No. 18.)

Photo No. 17: Mortar breaking down and missing.

Repointing of the entire interior masonry walls is recommended in the next 1-2 years. The severely deteriorated areas should be addressed immediately. The adjustable columns should be replaced with permanent columns on proper footings.

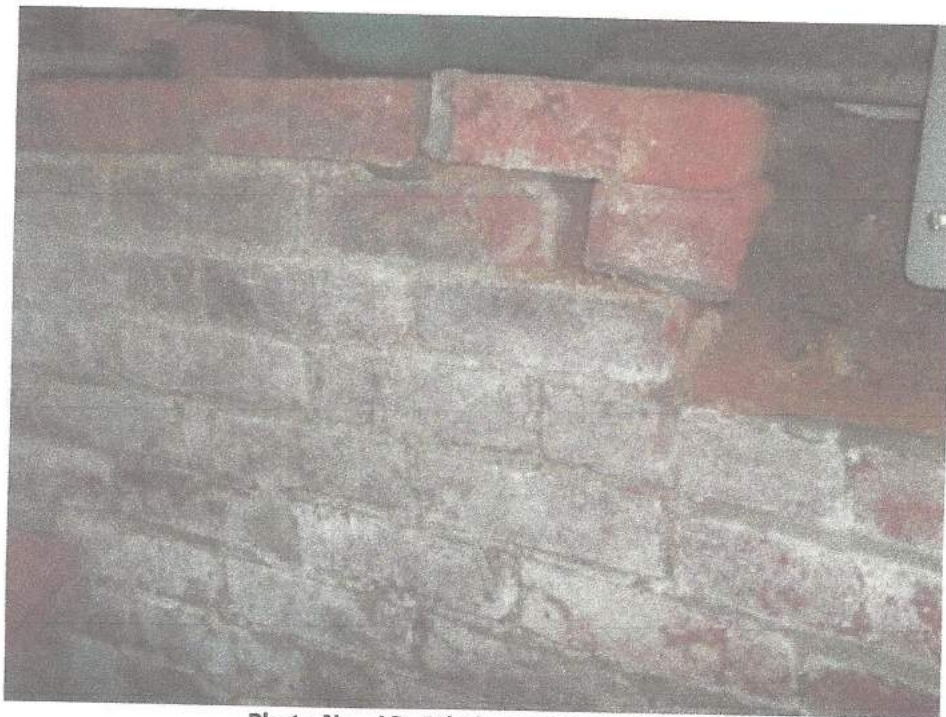
Photo No. 18: Missing and loose brick.

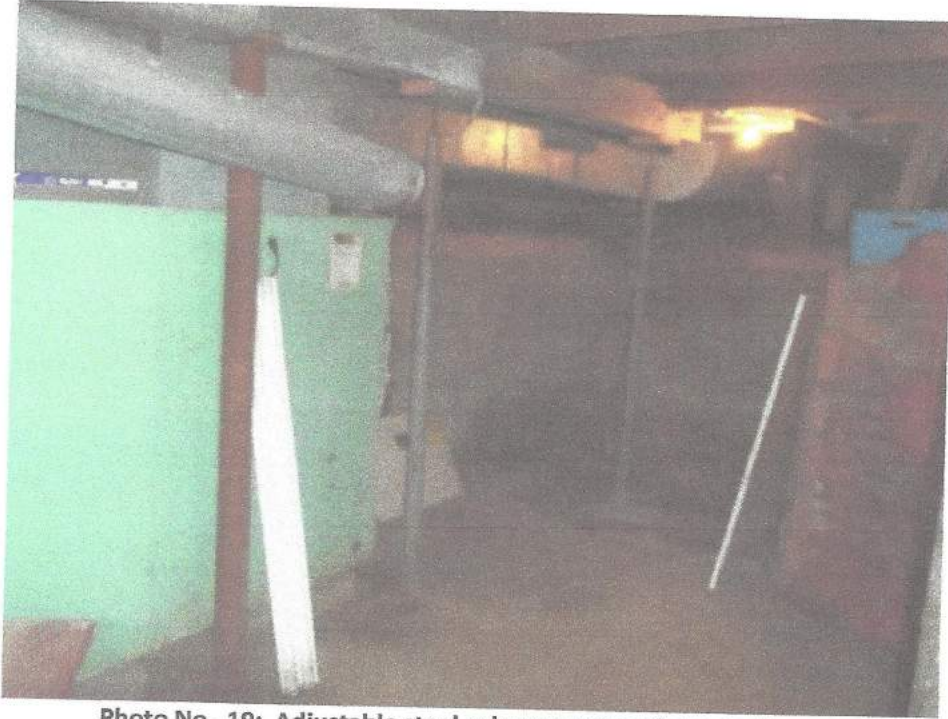
- The middle wood beams under the alter area supported by several adjustable columns. These columns are in close intervals and have decay at their bases. These are not stable and should be replaced with a permanent member. (Refer to Photo No. 19.)

Photo No. 19: Adjustable steel columns supporting wood beam.

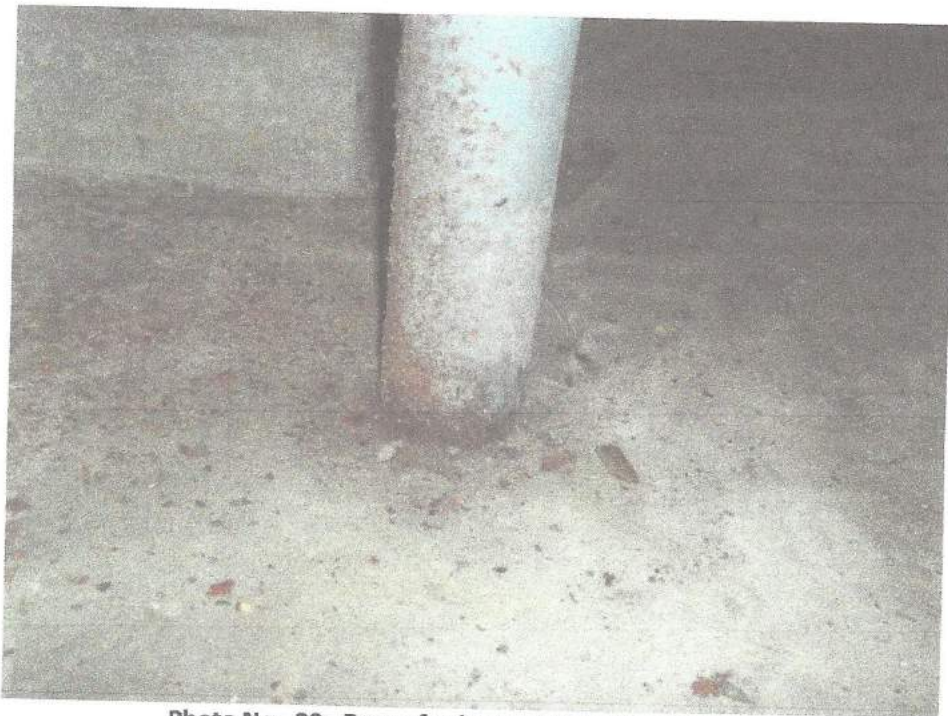
- The original steel fixed columns are rusted. New support columns may be needed in the future. Monitor over time. (Refer to Photo No. 20.)
- The main wood support beam has concrete footings with posts added at close intervals. These are all in good condition.

Photo No. 20: Base of columns have rust and decay.

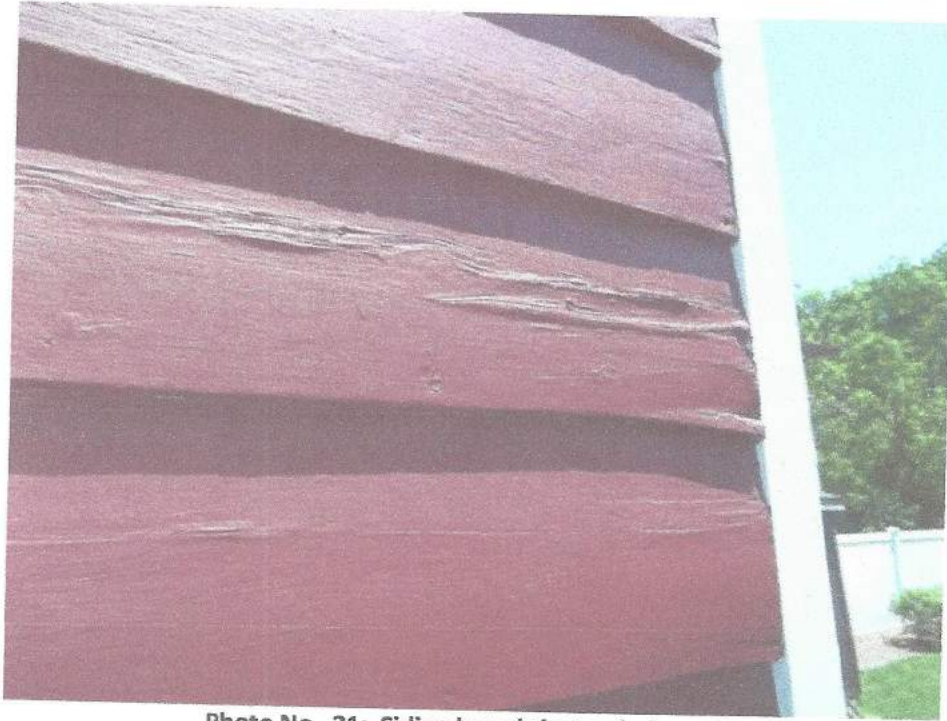
- Wide plank wood clapboard siding is in good condition.
- Some siding boards are split and have bubbled painted areas. Repair may be needed soon. (Refer to Photo No. 21.)
- Some boards are loose and need to be fastened. (Refer to Photo No. 22.)
- The vertical wood corners need caulking along the edges where they meet the siding.
- The vertical joints between the siding boards need caulking.
- The displaced siding board on the rear wall needs to be reinstalled. (Refer to Photo No. 23.)
- The cedar roof is in fair condition.
- The flashing around the back of the chimney needs to be repaired. Poor initial installation is apparent.
- The brick façade along the foundation is in fair condition.
- The main dwelling, one story section and front porch appear to be plumb and in good condition.

Photo No. 21: Siding boards in need of repair.

Repair and replace any damaged wood siding boards as needed. Decayed and displaced boards should be addressed immediately to prevent damage to the material behind the siding.

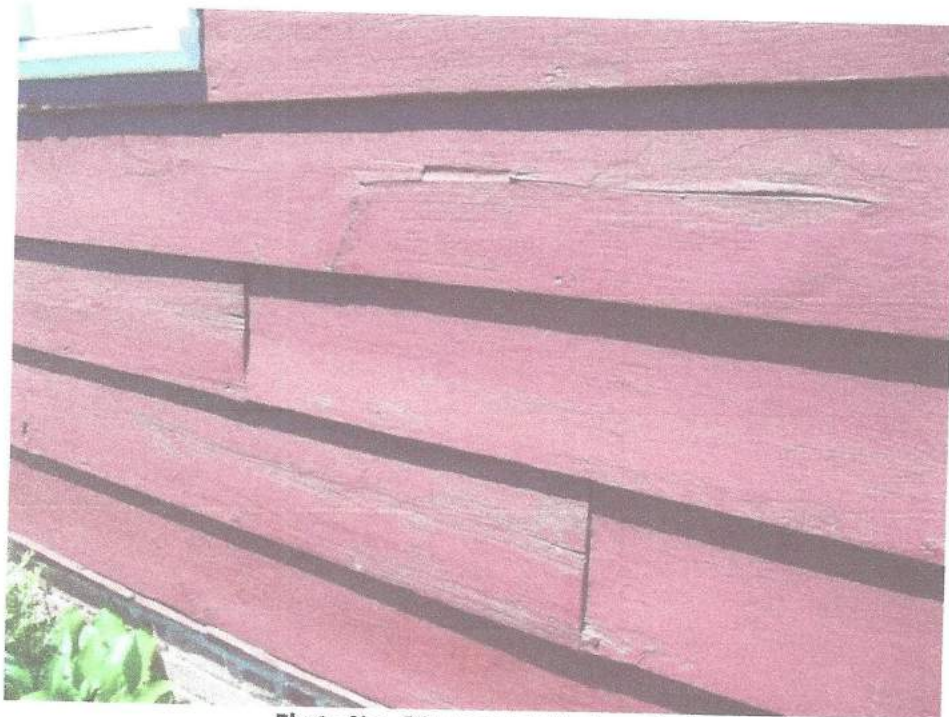
Photo No. 22: Loose siding board.

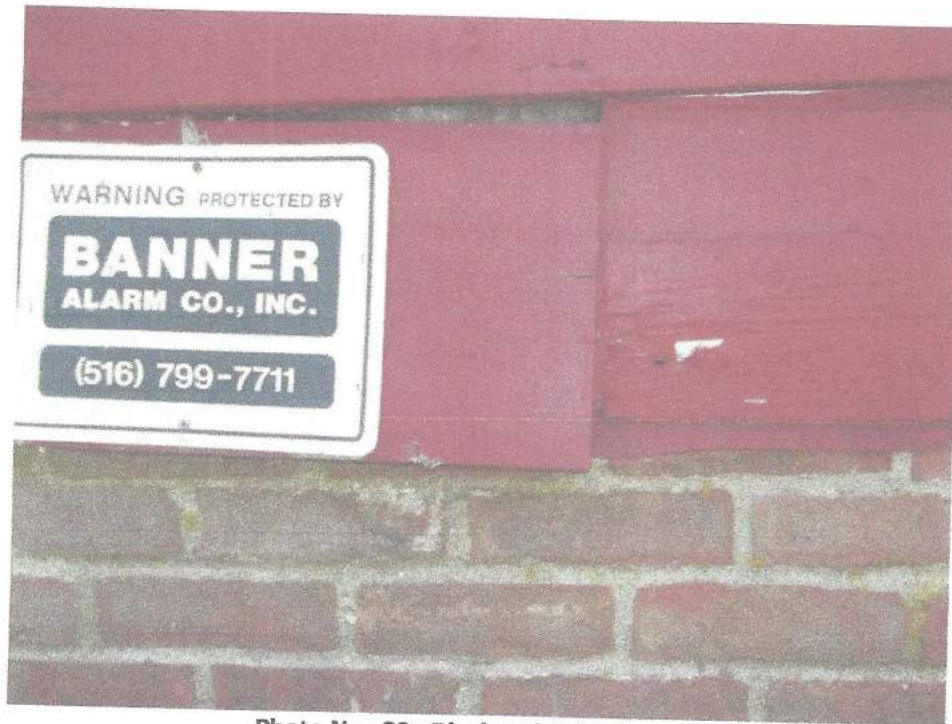
Photo No. 23: Displaced siding board.

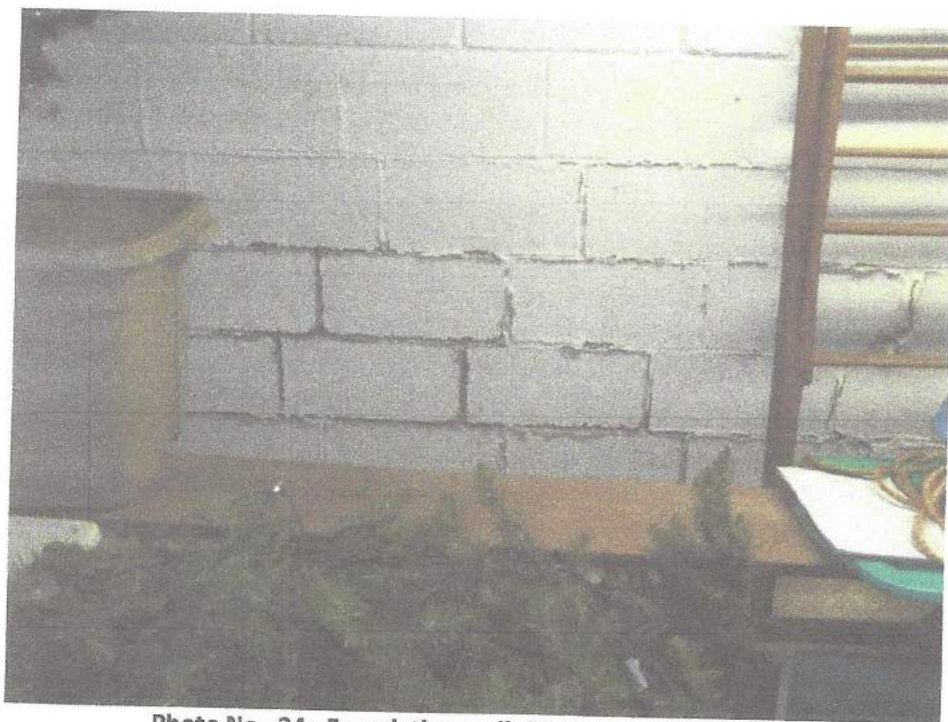
- The foundation is a newer concrete block structure in good condition with no apparent cracking.
- The southern wall and the south end of the western wall has water infiltration. (Refer to Photo No. 24.)
- Water infiltration is also occurring at the Bilco door area.
- This door system is in poor condition. replacement is recommended. (Refer to Photo No. 25.)
- The newer floor joists are in good condition.
- Prior rodent infestation is apparent.
- The floor drain was installed in an ineffective location. (Refer to Photo No. 26.)

Photo No. 24: Foundation walls have water infiltration.

The foundation walls with the water infiltration should be cleaned and repainted with a water resistive sealant in the next 2-4 months and monitored over time. The grade along the exterior on this south foundation wall and south end of the west foundation wall should be regraded to create a better pitch away from the structure for drainage or run-off.

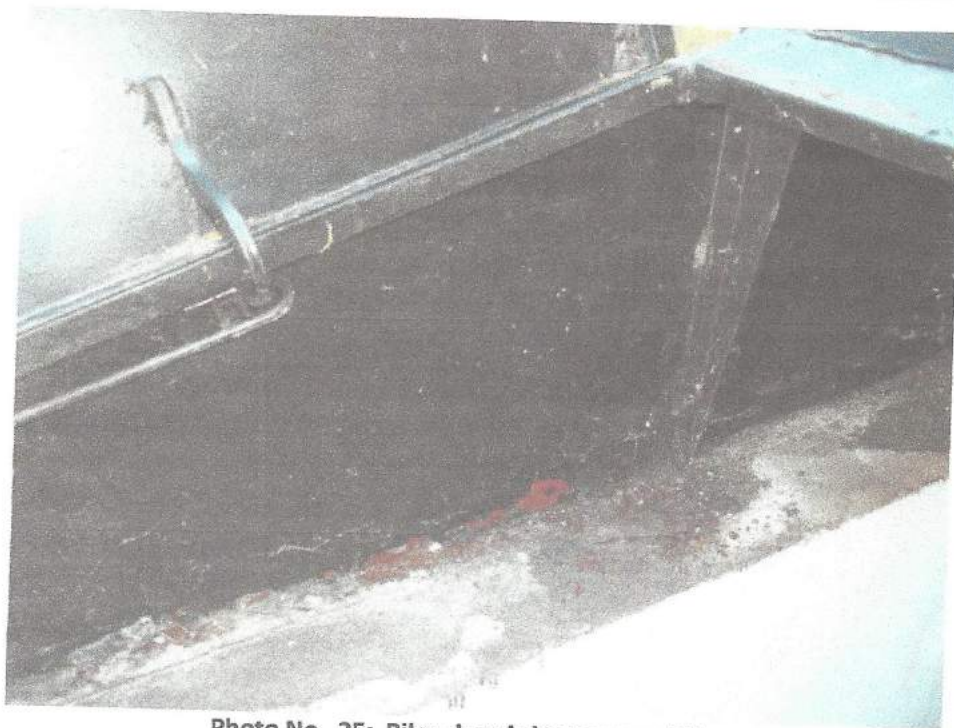
Photo No. 25: Bilco door is in poor condition.

The existing basement door should be replaced with new properly installed Bilco door. The floor drain should be relocated to the lower slab area to be most effective.

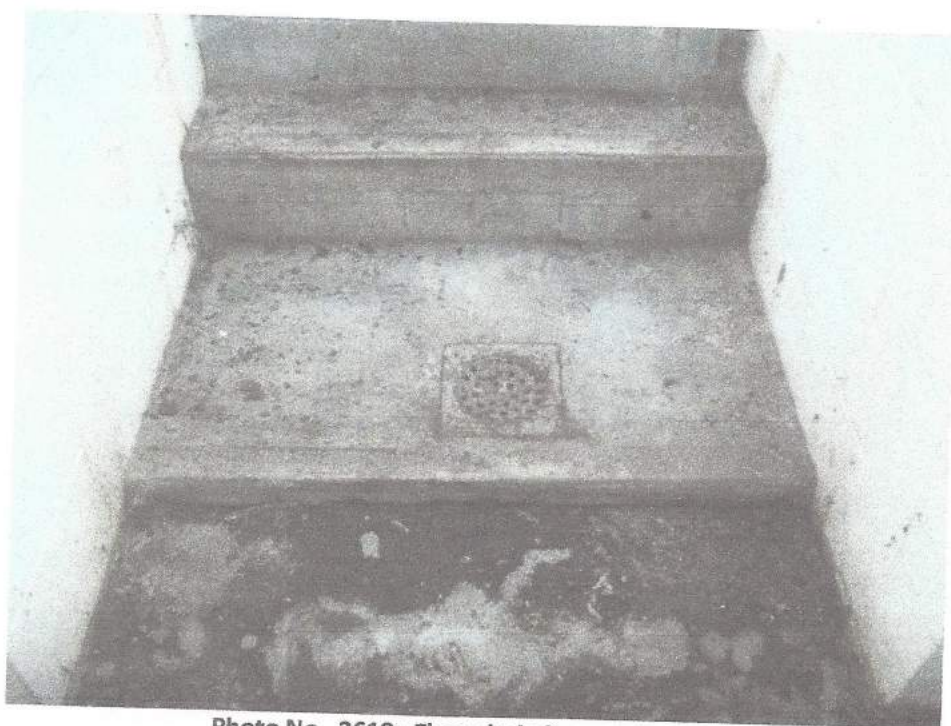
Photo No. 2610: Floor drain in concrete step.
